Flood Control Project Maintenance
2020 Structure Summary Report
Overall Unit and Item Ratings

City of Sacramento

El Camino Avenue Bridge

Magpie Creek Pumping Plant

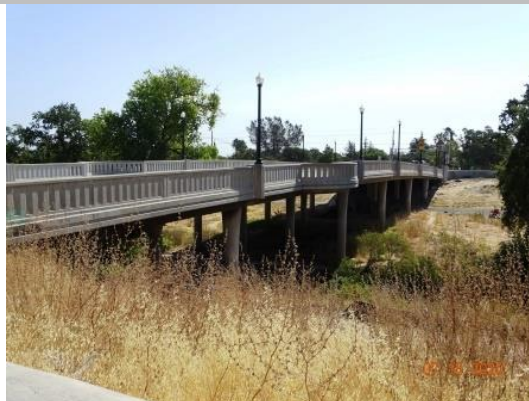
Photo 1 of 2 : ST_2020_NA0005_221_1_20200723_00027.jpg

| Inspector Comments: West El Camino bridge is inspected as a structure, because the bridge deck is below the design water surface elevation, causing the wingwalls and guard railing to act as flood walls during high water events. | | | | | |

View of the El Camino Bridge from the west end. Summer 2020

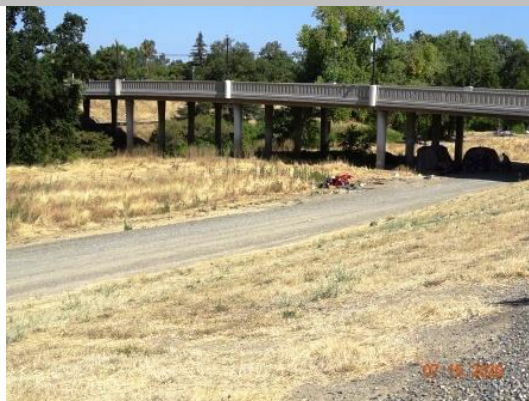
Photo 2 of 2 : ST_2020_NA0005_221_1_20200723_00028.jpg

View of the El Camino Bridge from the east end. Summer 2020

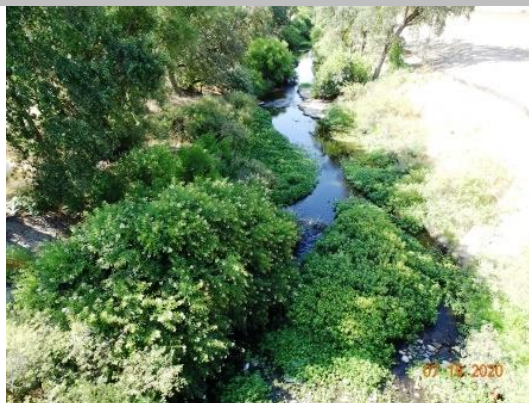
Photo 1 of 2 : ST_2020_NA0005_221_2_20200723_00030.jpg

| Inspector Comments: Woody vegetation downstream of the bridge worsened and may impede flows. | | | | | |

View of downstream vegetation. Summer 2020

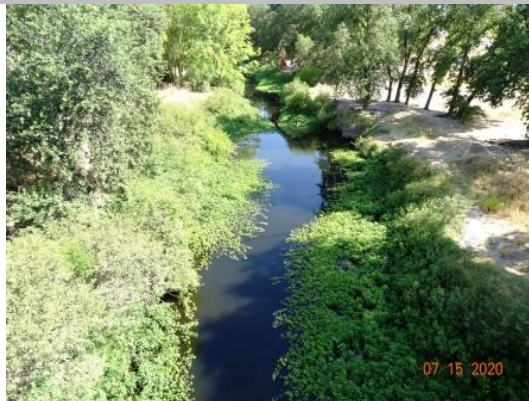
Photo 2 of 2 : ST_2020_NA0005_221_2_20200723_00029.jpg

| Inspector Comments: Woody vegetation downstream of the bridge worsened and may impede flows. | | | | | | |

View of upstream vegetation. Summer 2020

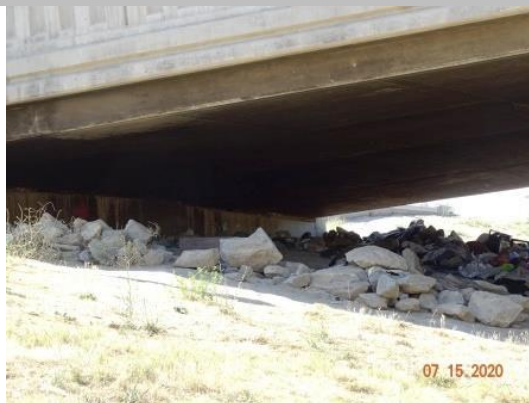
Photo 1 of 2 : ST_2020_NA0005_221_5_20200723_00040.jpg

| Inspector Comments: Riprap underneath the bridge ends appears to be displaced by campers. | | | | | |

View of revetment underneath the east end of the bridge. Summer 2020

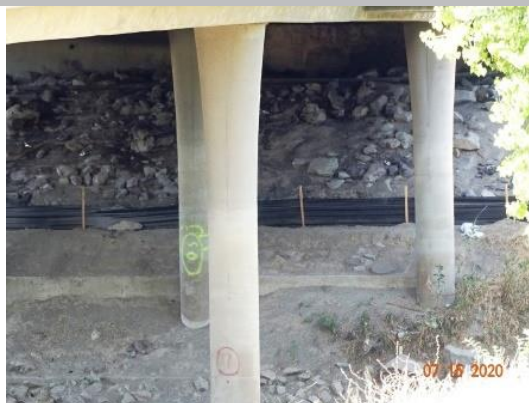
Photo 2 of 2 : ST_2020_NA0005_221_5_20200723_00039.jpg

View of revetment underneath the west end of the bridge. Summer 2020

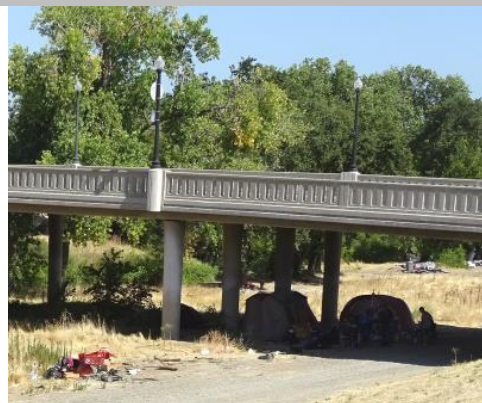
Photo 1 of 2 : ST_2020_NA0005_221_6_20200723_00043.jpg

| Inspector Comments: Camps are set up underneath the bridge and on the east slope. | | | | | |

View of long-standing camps underneath the bridge. Summer 2020

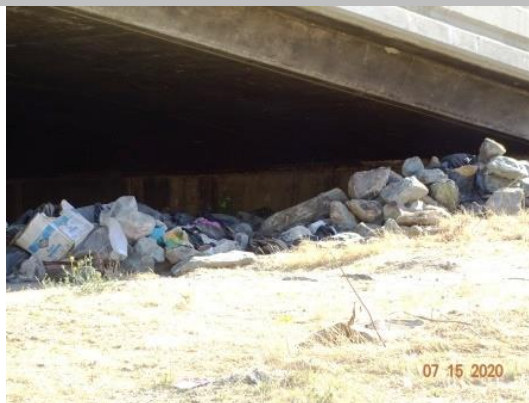
Photo 2 of 2 : ST_2020_NA0005_221_6_20200723_00031.jpg

| Inspector Comments: Camps are set up underneath the bridge and on the east slope. | | | | | | |

View of camper debris and displaced riprap underneath the east end of the bridge. Summer 2020

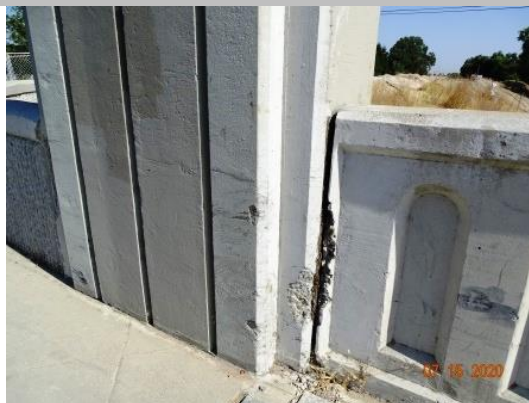
Photo 1 of 2 : ST_2020_NA0005_221_15_20200723_00041.jpg

| Inspector Comments: There is minor spalling and cracking at the north ends of the bridge. | | | | | |

View of minor spalling at the northwest end of the bridge. Summer 2020

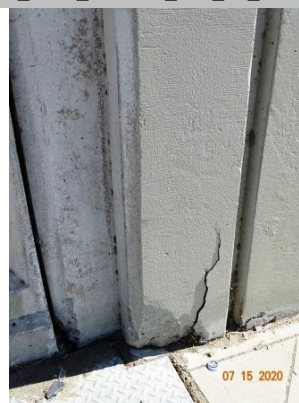
Photo 2 of 2 : ST_2020_NA0005_221_15_20200723_00042.jpg

View of minor cracking at the northeast end of the bridge. Summer 2020

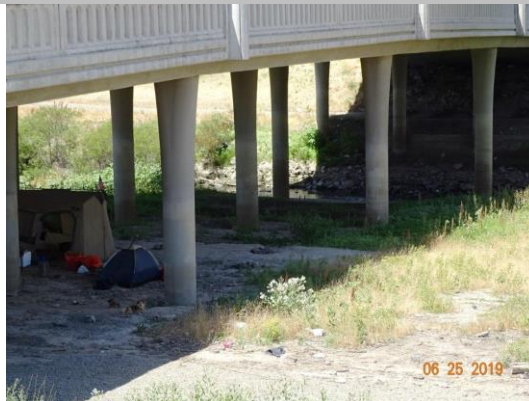
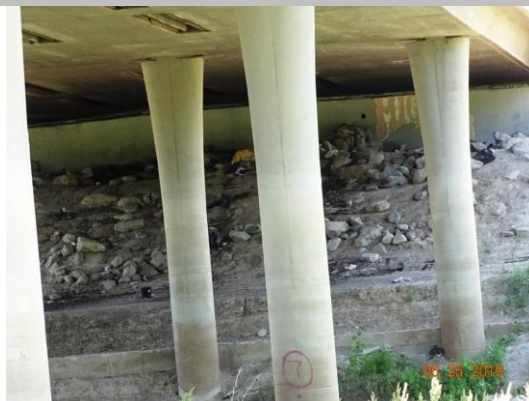
| Inspector Comments: There is no apparent scouring or erosion at the footings of the structure. | | | | | |

View looking west at the bridge piers. Summer 2019

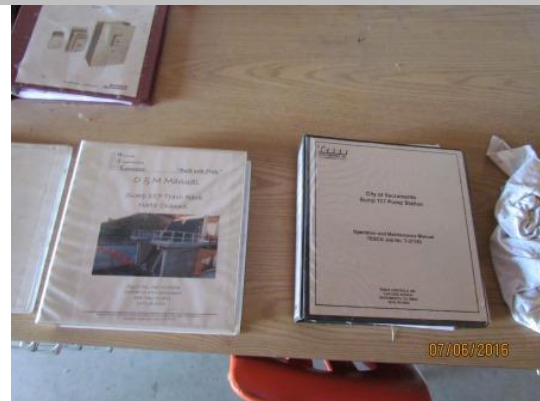
Photo 2 of 2 : ST_2020_NA0005_16_2_20200622_00003.jpg

View of O&M manuals in the plant, but they are not written by the USACE. Summer 2017

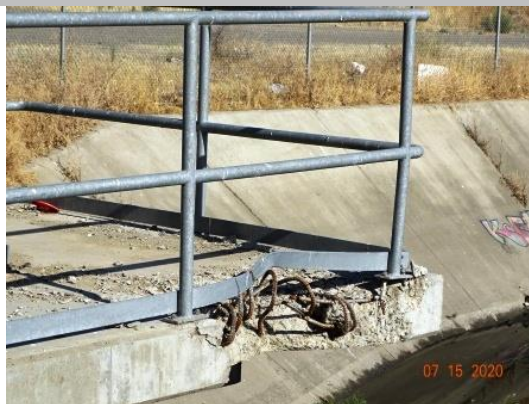
Photo 1 of 4 : ST_2020_NA0005_16_5_20200721_00045.jpg

View of damaged walkway near trash rakes due to a vehicular rollover accident from overpass. Summer 2020

| Inspector Comments: Repair damaged concrete walkway and metal railings from a vehicular rollover accident off of overpass. | | | | | |

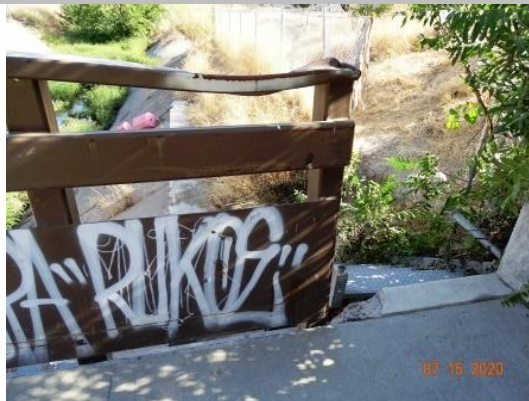
Photo 2 of 4 : ST_2020_NA0005_16_5_20200721_00044.jpg

View of damaged railing and stairway near trash rakes. Summer 2020

| Inspector Comments: Repair damaged concrete walkway and metal railings from a vehicular rollover accident off of overpass. | | | | | | |

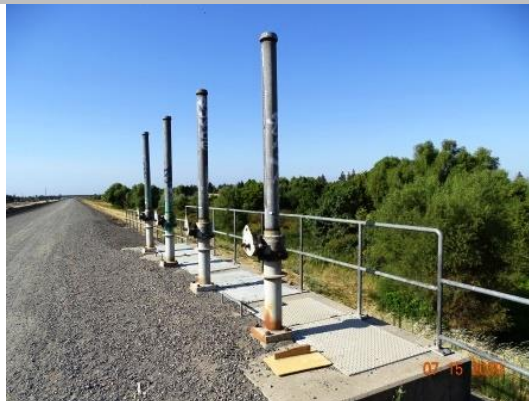
Photo 1 of 1 : ST_2020_NA0005_16_17_20200722_00060.jpg

View of the manual gate operators. A hydraulic wrench is centrally stored at another facility. Summer 2020

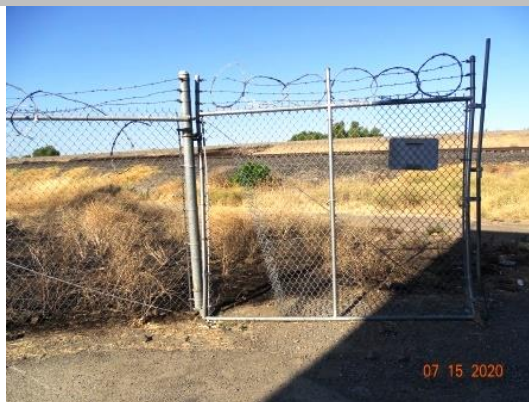
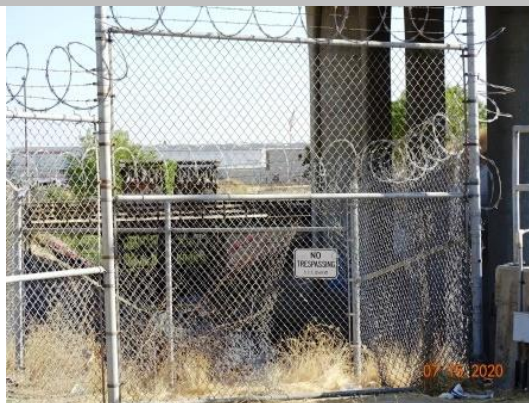
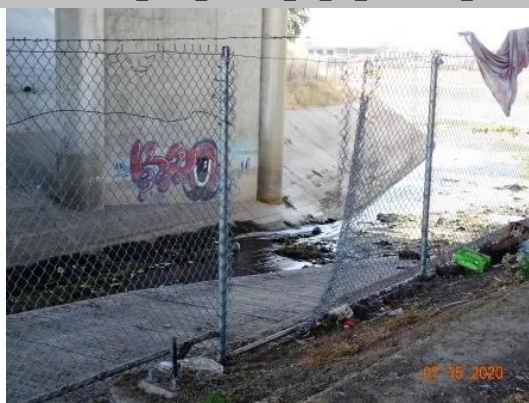
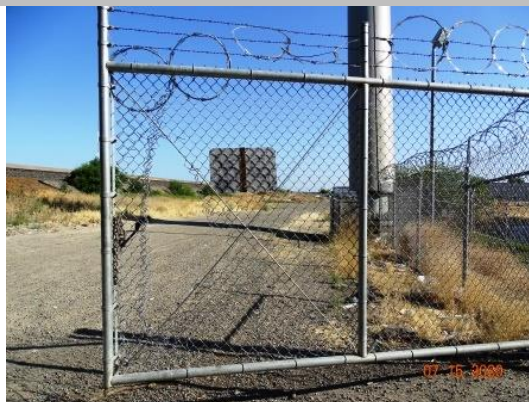
View of breach in the fence. Summer 2020
